# Manhole Inspection Summary

Manhole # S3100\_007MH

Insp Date: **4/25/07 10:48 AM**

**Location** Address: **330 HAMDEN AVE**

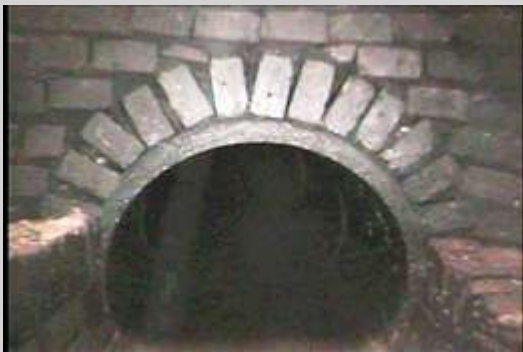
### 20 in. Circular Gravity Sewer Pipe Out @ 12 O'Clock

Invert Depth: **15.20** (ft.) Flow Characteristics: **Fast**

Infiltration: **None** Pipe Seal Cond: **Unknown**

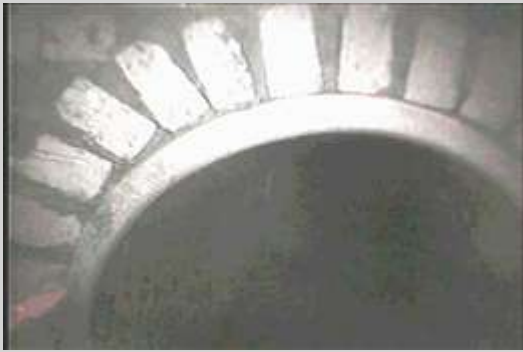
Pipe In @ 6 O'Clock

Invert Depth: **15.10** (ft.) Flow Characteristics: **Fast**

Infiltration: **None** Pipe Seal Cond: **Unknown**

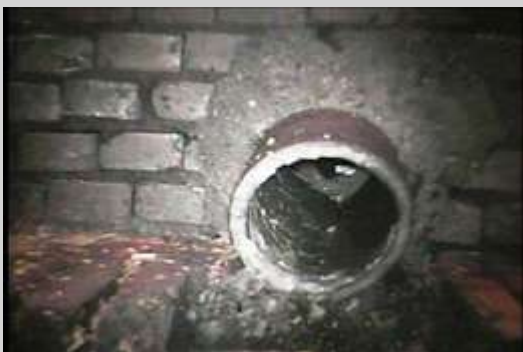
Pipe In @ 9 O'Clock

Infiltration: **None** Pipe Seal Cond: **Unknown**
